Site 13C. Imeson International Industrial Park, Inc./Barnett Banks Trust Co. Parcel

Site 13D. Barnett Bank Trust Co. (Bostwick Trust) Parcel

Site 13E. Imeson/Carlos Cedar Bay Road Parcel

Site 16. Polly Town

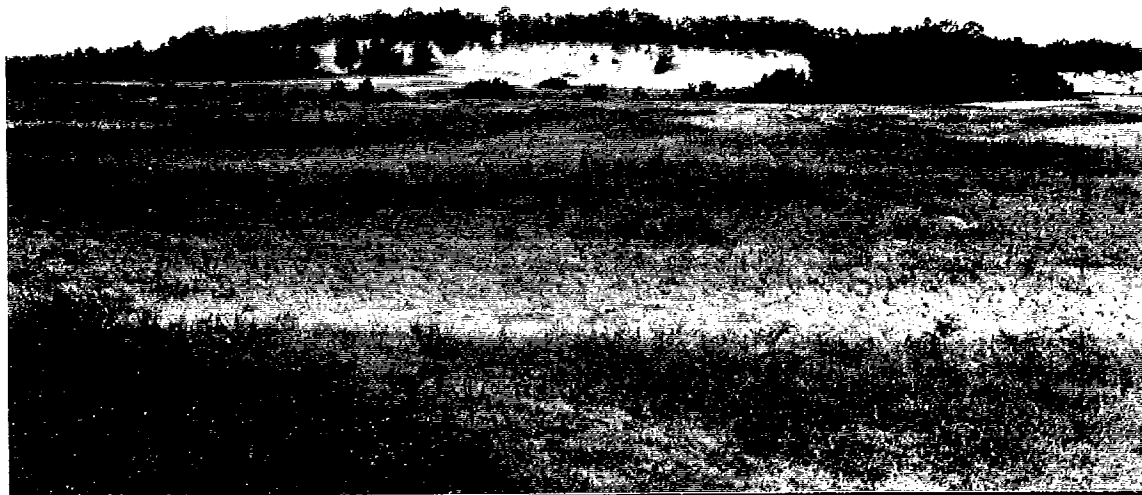
The original soil associated with Site 13C was Kershaw-Ortega. Sand mining has destroyed all but about 5% of the native sandhill community associated with this excessively drained soil. The southern third of the parcel, which is no longer actively mined, is saucer shaped with gently to moderately sloped ridges and isolated knolls interspersed with dry depressions (Figure 14). This area is primarily vegetated with ground cover consisting of pioneer grasses (*Andropogon* sp.) and early successional herbaceous plants, including partridge pea (*Cassia chamaecrista*), sandspur (*Cenchrus* sp.), and ragweed (*Ambrosia* sp.). Approximately two dozen mostly large and active gopher tortoise burrows were observed in this area (Figure 15). An Eastern diamondback rattlesnake (*Crotalus adamanteus*) was observed at the entrance of one of the active burrows. The lack of smaller diameter tortoise burrows suggests that the population lacks reproductive viability and may be a remnant of a larger, self-sustaining population that was likely associated with the original sandhill habitat. As a state species of special concern, any impacts to the gopher tortoise would first have to be coordinated with the Florida Game and Fresh Water Fish Commission.

Figure 14. Inactive sand mine area.

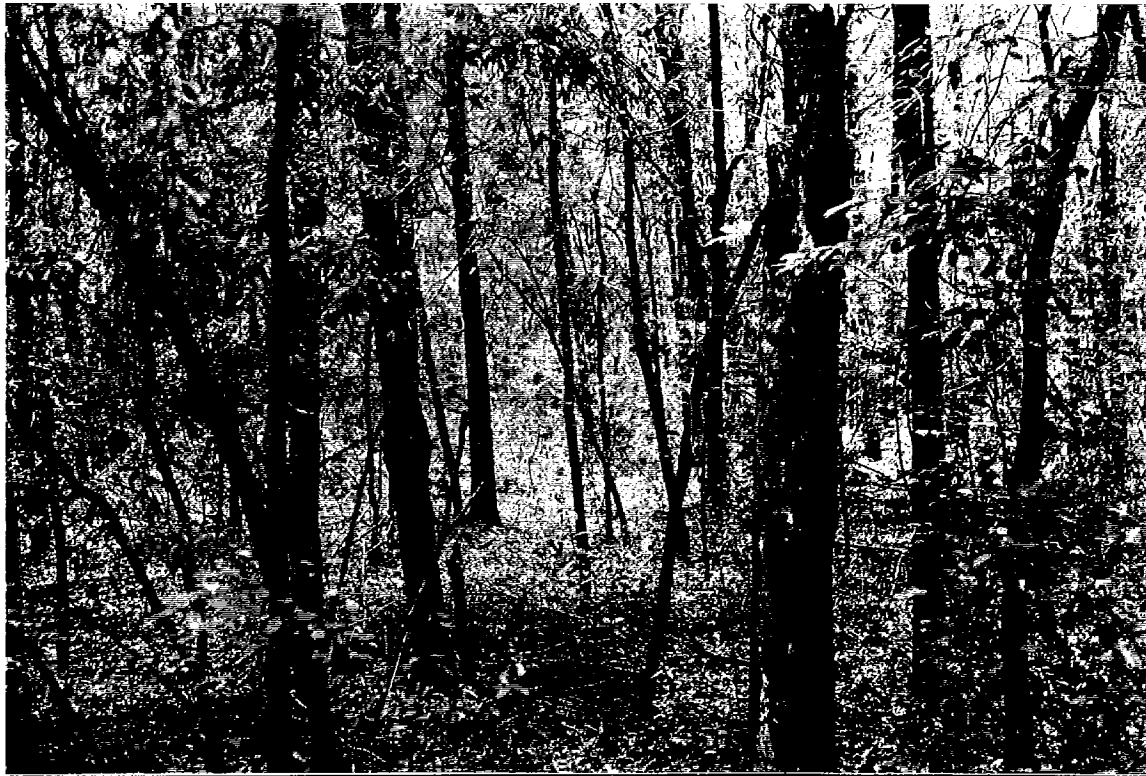
A mesic hardwood hammock occurs along the border of the river at the lowest elevations. Hammock width ranges from about 150 to 800 feet, with the older growth closest to the river. The canopy consists of live oak, laurel oak, southern magnolia (*Magnolia grandifolia*), and pignut hickory (*Carya glabra*); the understory includes black cherry (*Prunus serotina*), dogwood (*Cornus florida*), redbud (*Cercis canadensis*), witchhazel (*Hamamelis virginiana*), and persimmon (*Diospyros virginia*). The shrub layer includes wax myrtle (*Myrica cerifera*), beauty berry (*Callicarpa americana*) and blueberries (*Vaccinium* spp.) (Figure 17). Some small, narrow patches of fringing salt marsh occur along the hammock's border with the Broward River.

Figure 17. Mesic hardwood hammock community.

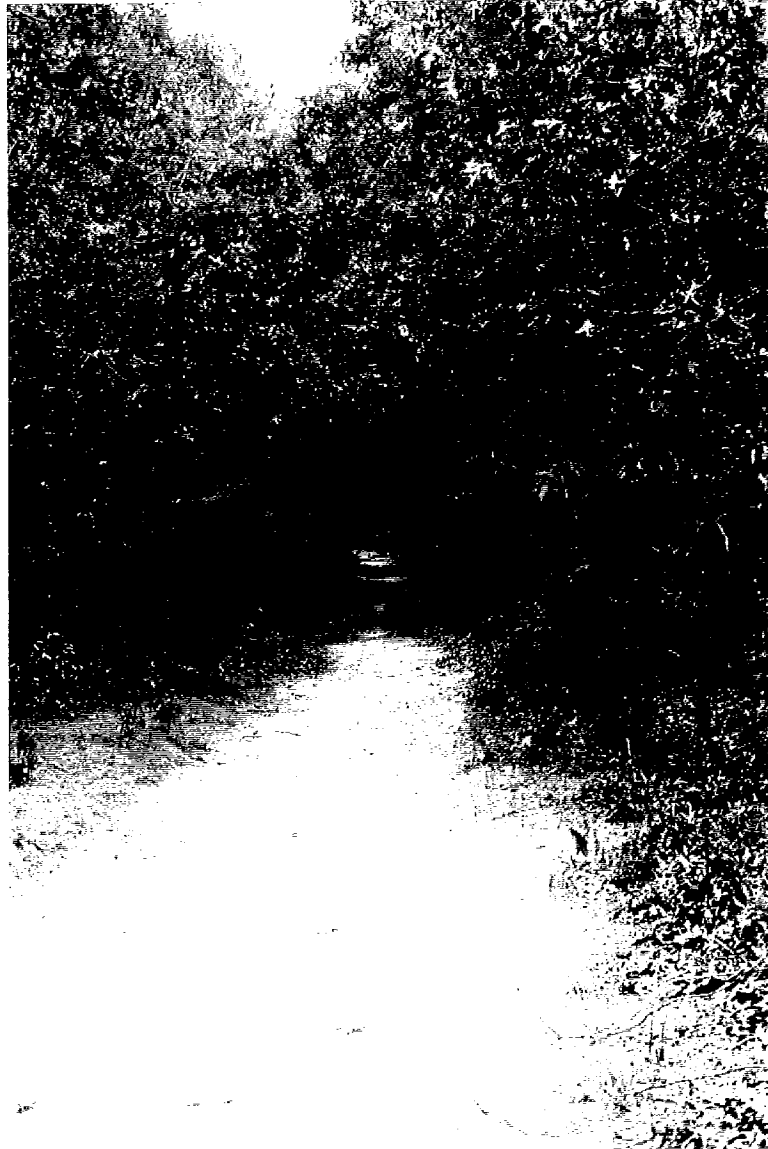
The western half of the site consists of an unbalanced longleaf pine-turkey oak forest. The canopy contains scattered mature longleaf pine and many relatively young turkey oak as well as other hardwoods such as post oak (*Quercus stellata*), bluejack oak (*Quercus incana*), sassafras (*Sassafras albidum*), and persimmon. The structure and age of these trees indicate that the area had been logged in the past, but not burned (Figure 18). Some regeneration of longleaf pine is occurring along roadsides (Figure 19). The shrub and ground cover layers include blueberry (*Vaccinium* spp.), saw palmetto, chinquapin (*Castanea* sp.), wiregrass (*Aristida stricta*), and gopher apple (*Licania michauxii*).

Figure 18. Turkey oak dominated sandhill community.

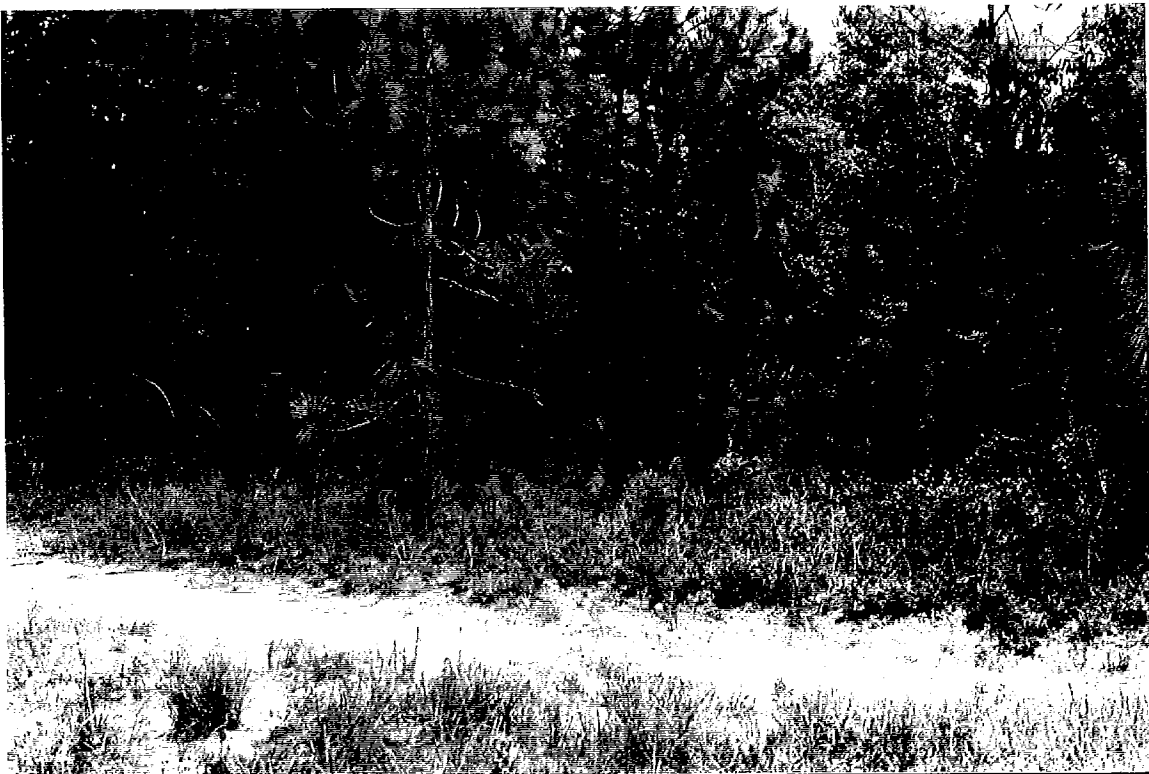
The northwestern, northeastern, and southwestern portions of this site are disturbed uplands with two large fields and a number of smaller open areas, usually associated with the intersections of old logging roads. The large field in the northeastern corner is an unvegetated former sand mining pit, while the other field exhibits early vegetative succession and is dominated by grasses and herbaceous forbs (Figures 22 and 23). The smaller openings exhibit advanced plant succession and include numerous grape vines (*Vitus rotundifolia*) and various woody shrubs such as wax myrtle, shiny sumac (*Rhus copallina*) and yaupon (*Ilex vomitoria*) (Figure 24). The remainder of the vegetative community within these portions consists of a mixture of longleaf and slash pine and mixed oak associations similar to the disturbed sandhill community within site 13A. Significant longleaf pine regeneration was evident in the smaller open areas and along some sections of roadside. Active gopher tortoise burrows were observed in similar areas as well as within the large successional field. The range of burrow sizes suggests that these sections support one or more self-sustaining populations (Figures 25 and 26).

Figure 25. Longleaf pine regeneration along roadside.

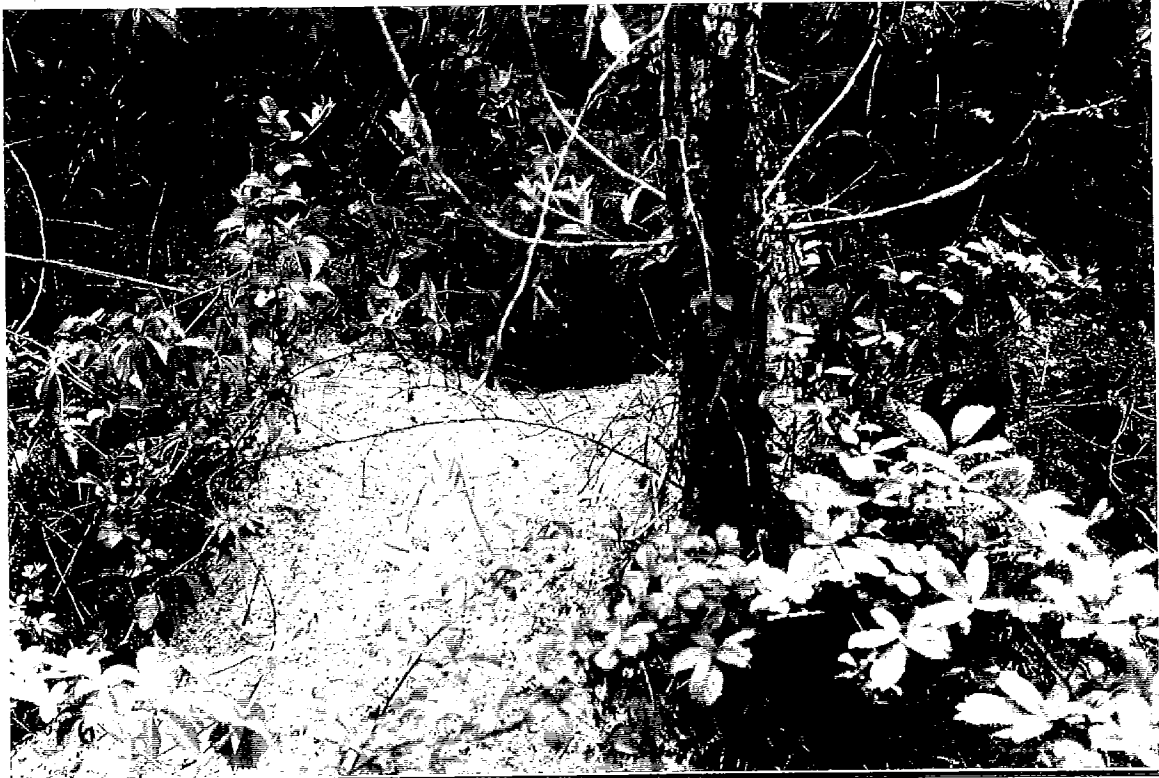
Figure 26. Active gopher tortoise burrow.

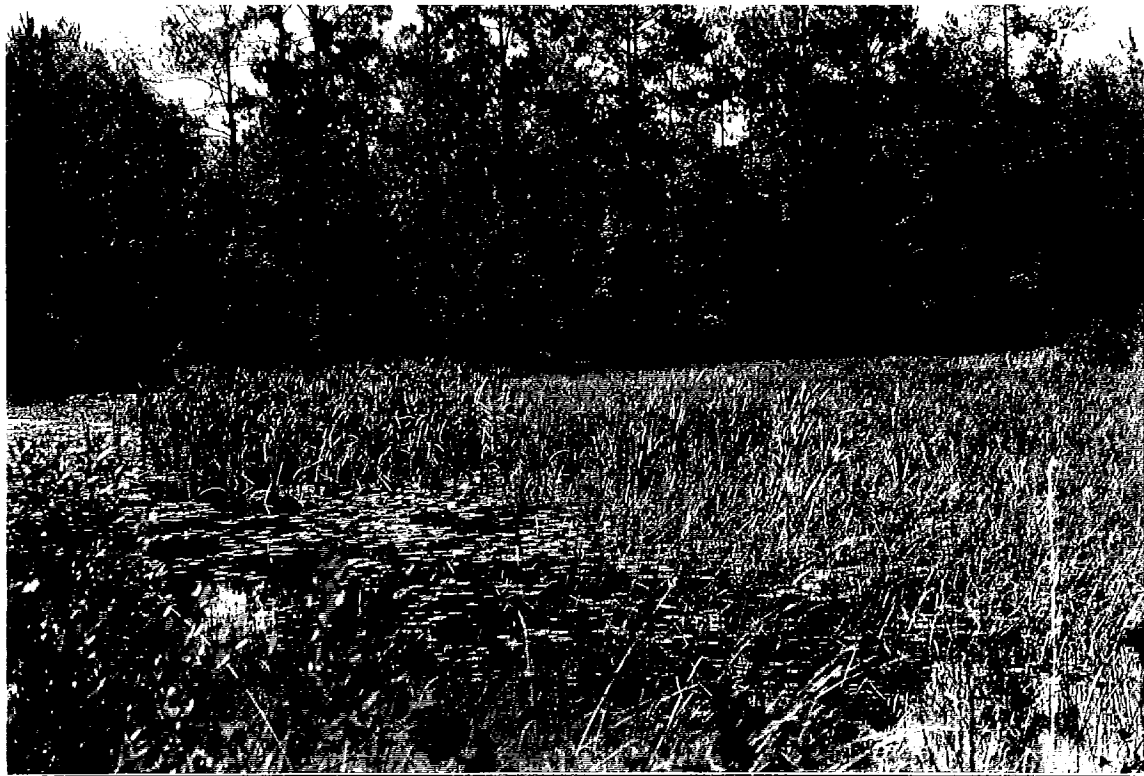
The on-site wetlands consist of two shallow, connected ponds and two narrow, mixed forested drainages totaling between 10 and 15 acres. Floating and emergent aquatic vegetation associated with the ponds included water shield (*Brasenia schreberi*), white water lily (*Nymphaea odorata*), spatterdock (*Nuphar luteum*), cattail, and spikerush (*Eleocharis* sp.). The drainages contained red maple, slash pine, gallberry (*Ilex glabra*), elderberry (*Sambucus canadensis*) and chain fern (*Woodwardia* sp.). Wood ducks (*Aix sponsa*) were observed at one of the ponds (Figures 28 and 29).

Figure 28. Sandhill pond.

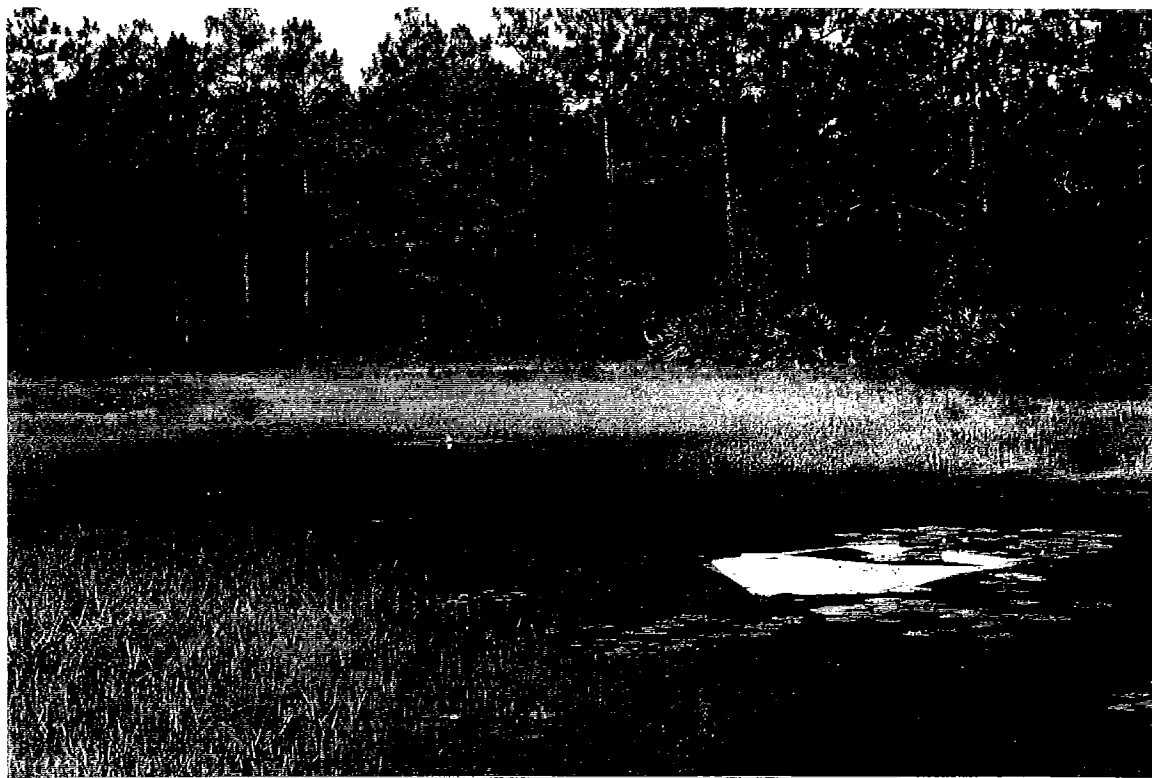
Figure 29. Sandhill pond.
